ShUM SITES OF SPEYER, WORMS AND MAINZ

Nomination for the UNESCO World Heritage List

Additional Information

Answers to the additional information requested on the nomination of *ShUM Sites of Speyer, Worms and Mainz (Germany)* to the World Heritage List received from ICOMOS on the 22 September 2020

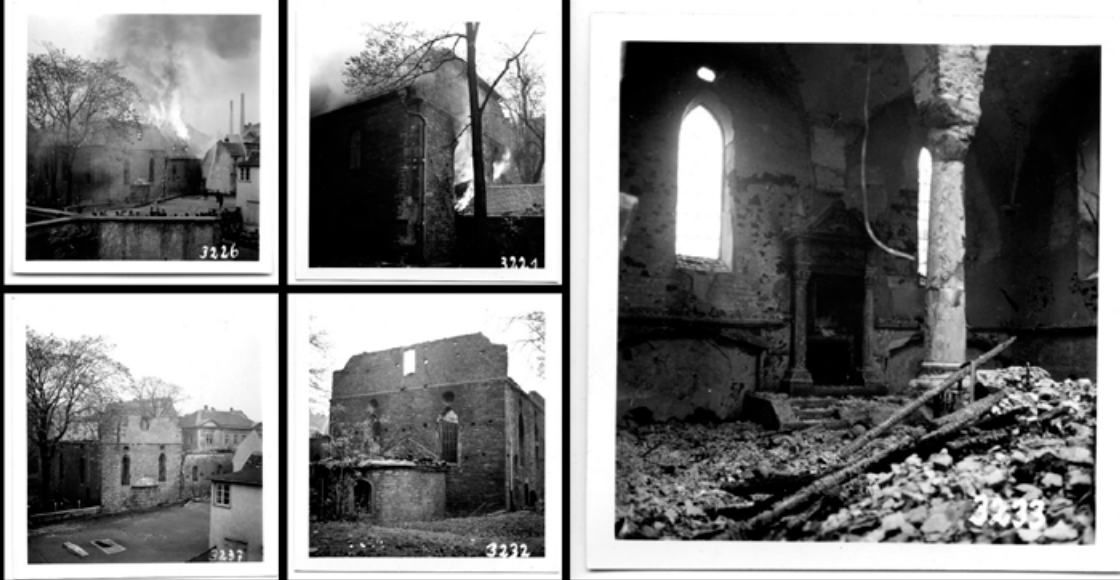
Worms Synagogue Compound
after the walls and vaults were
purposely collapsed

A letter from the city archivist Friedrich M. Illert to the city's mayor in August 1947 attests that the synagogue was demolished in late 1939. Pressure applied by hydraulic presses then caused the walls of the synagogue to crumble inwards. Huge pieces of the wall fell to the ground in large blocks with smooth break edges. Large parts of the masonry bond, individual cuboids and even jamb stones from the arched windows remained intact, which is very well discernible on the reproductions of 1943 [→ Appendix A.6]. In parts, several meters of the masonry bond remained intact, and significant inscriptions and building fragments were buried and thereby preserved in the rubble. They were salvaged and stored by members of the Jewish community of Worms in the days and years to follow.

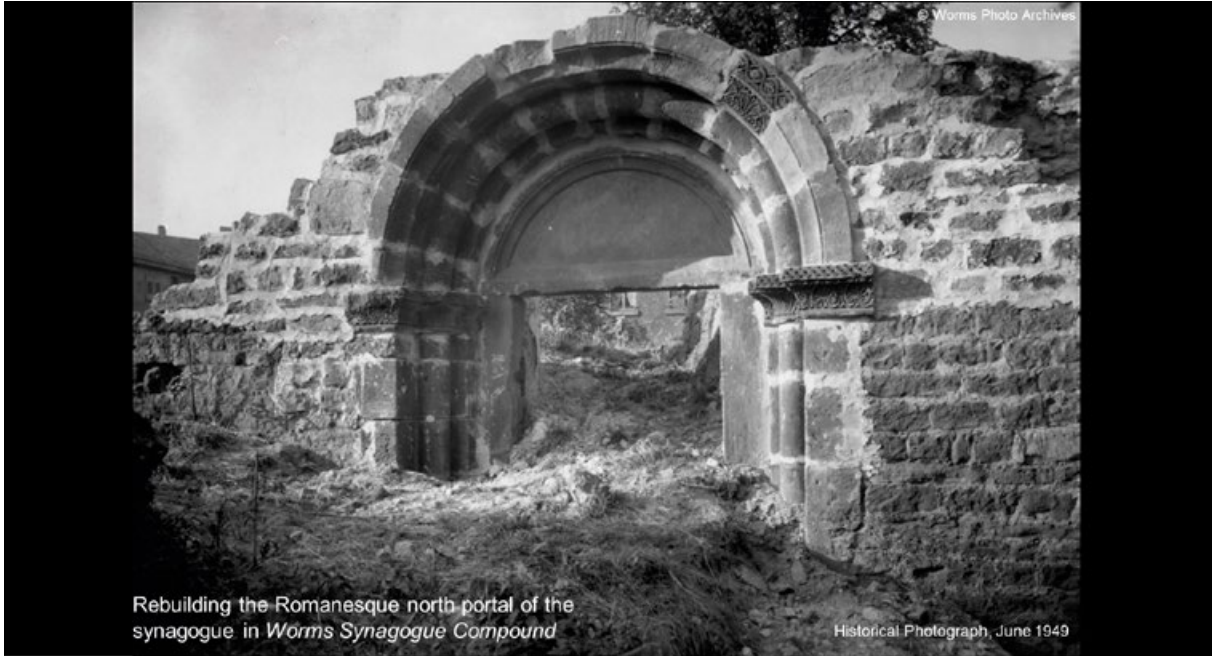
Rebuilding the Romanesque north portal of the synagogue in Worms Synagogue Compound

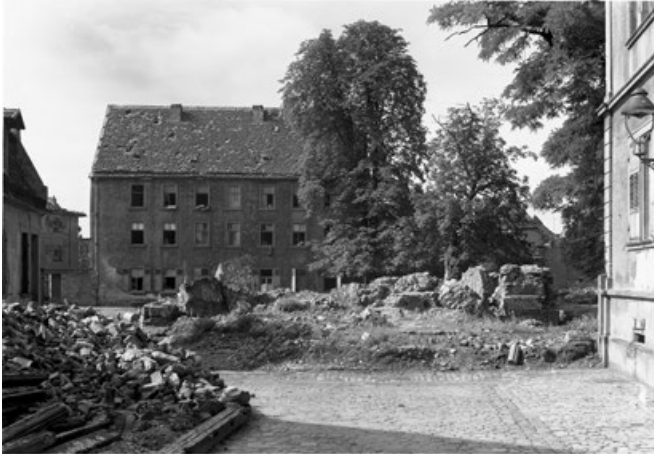
1. The destroyed *Worms Synagogue Compound* after the Second World War with the former community hall in the background. Viewed from the north.
Historical photograph, 6 July 1945

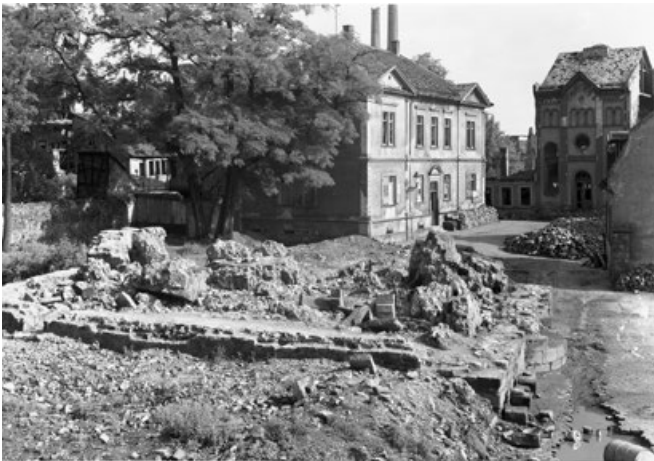
2. The destroyed synagogue compound in Worms after the Second World War. Viewed from the south.
Historical photograph, 6 July 1945

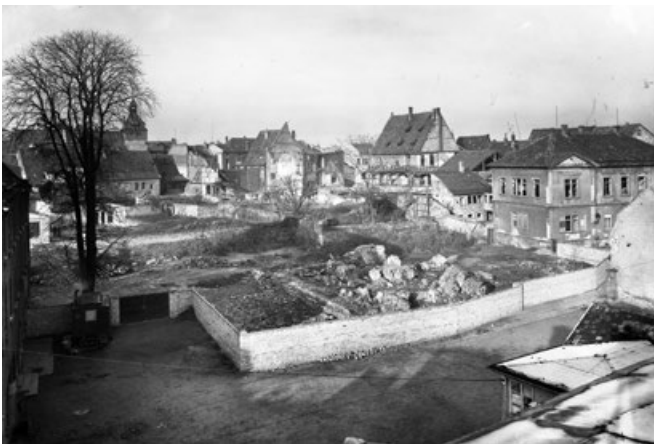
3. Overview of the destroyed *Worms Synagogue Compound* after the Second World War.
Historical photograph, 18 November 1947

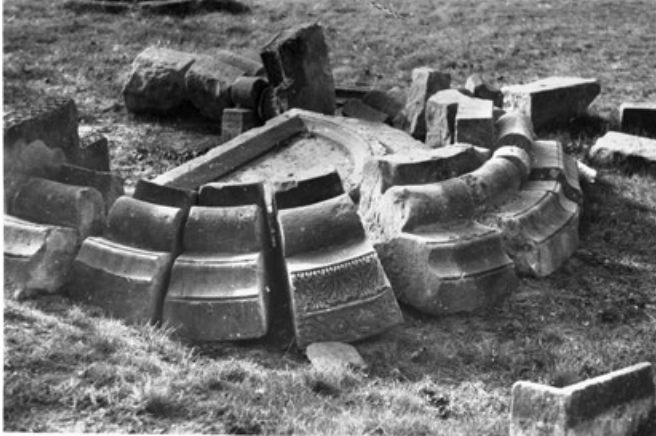
4. Original fragments of the north portal.
Historical photograph,
October 1948

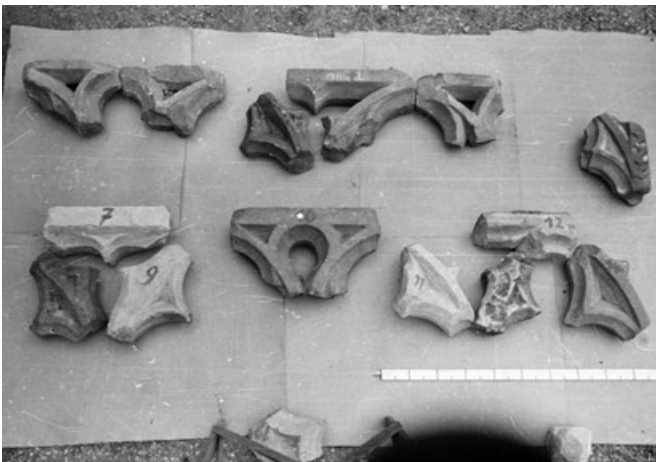
5. Example of the systematic sorting
of the original fragments.
Historical photograph, after 1945

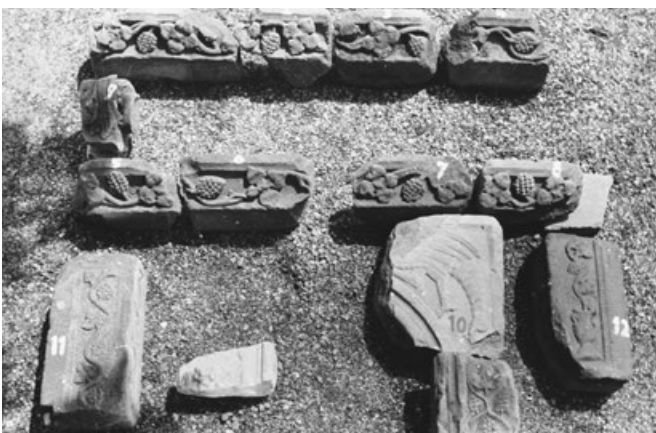
6. Example of the systematic sorting
of the original fragments.
Historical photograph, after 1945

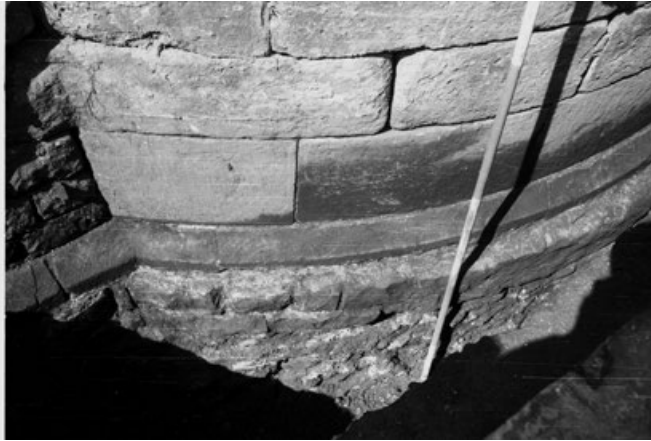
7. Excavation on the east wall of the synagogue 1956.
Historical photograph, 1956

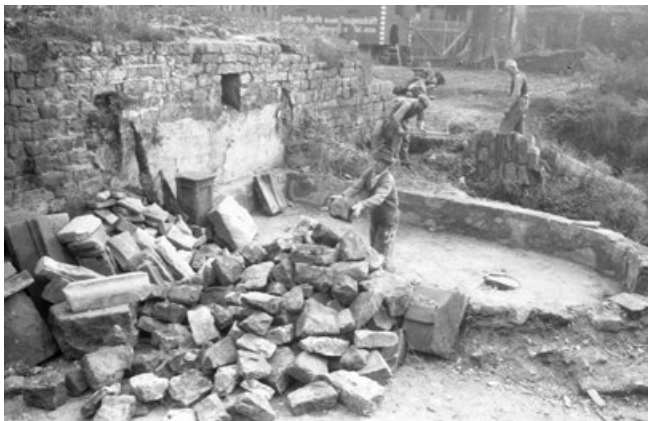
8. "Clearing the rubble" in *Worms Synagogue Compound* in preparation of its recovery and reconstruction.
Historical photograph, October 1957

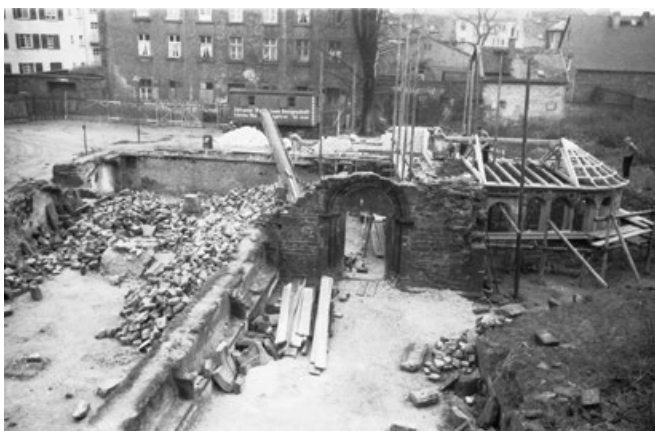
9. The rebuilt of the *yeshiva* in *Worms Synagogue Compound*.
Historical photograph, 1958

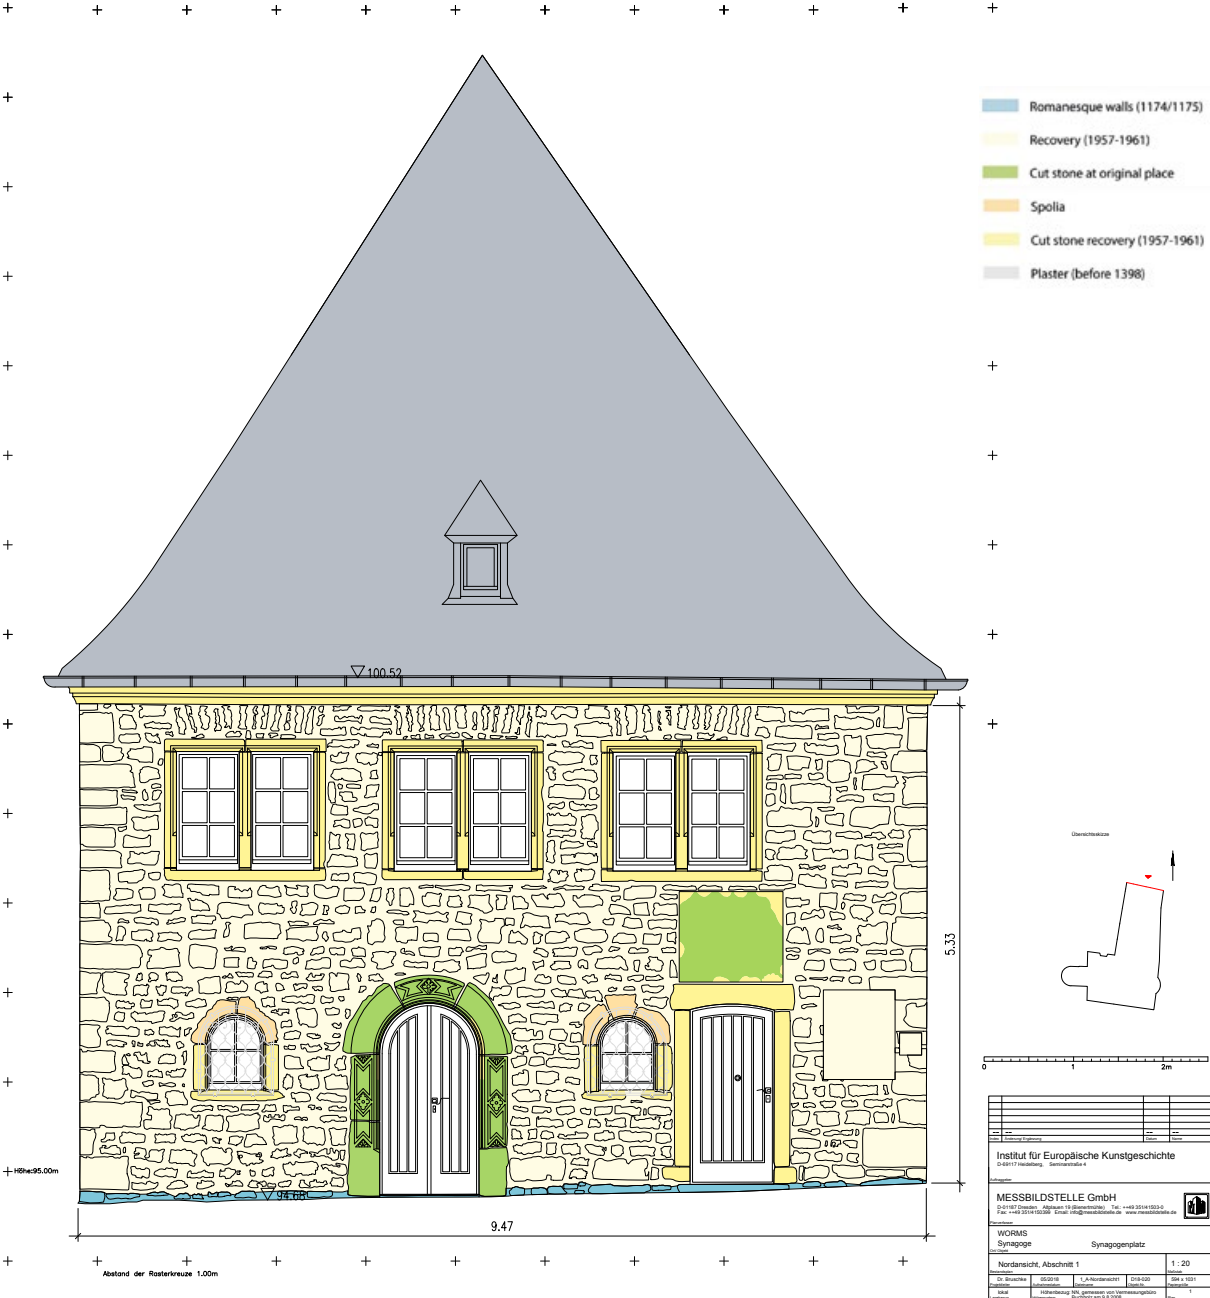
1. Construction phase plan of the nord façade with the Jewish council chamber and entrance hall of the *women's shul*

In 2018, the Institute for *European Art History at Heidelberg University* investigated the fabric of the synagogue and its adjacent buildings. The numerous photographs from the time before the war, from the time of the *Shoah* and the time of recovery were compared with the current fabric on site. Design elements such as window jambs and inscriptions were compared with the historical photos. The results of the investigation of the masonry, but also the height of the masonry as it could be reconstructed from various photographs from different periods, were recorded in the plans. In so doing, it was possible to get an extensive picture of the current fabric of the monuments in *Worms Synagogue Compound* → Appendix A.9.

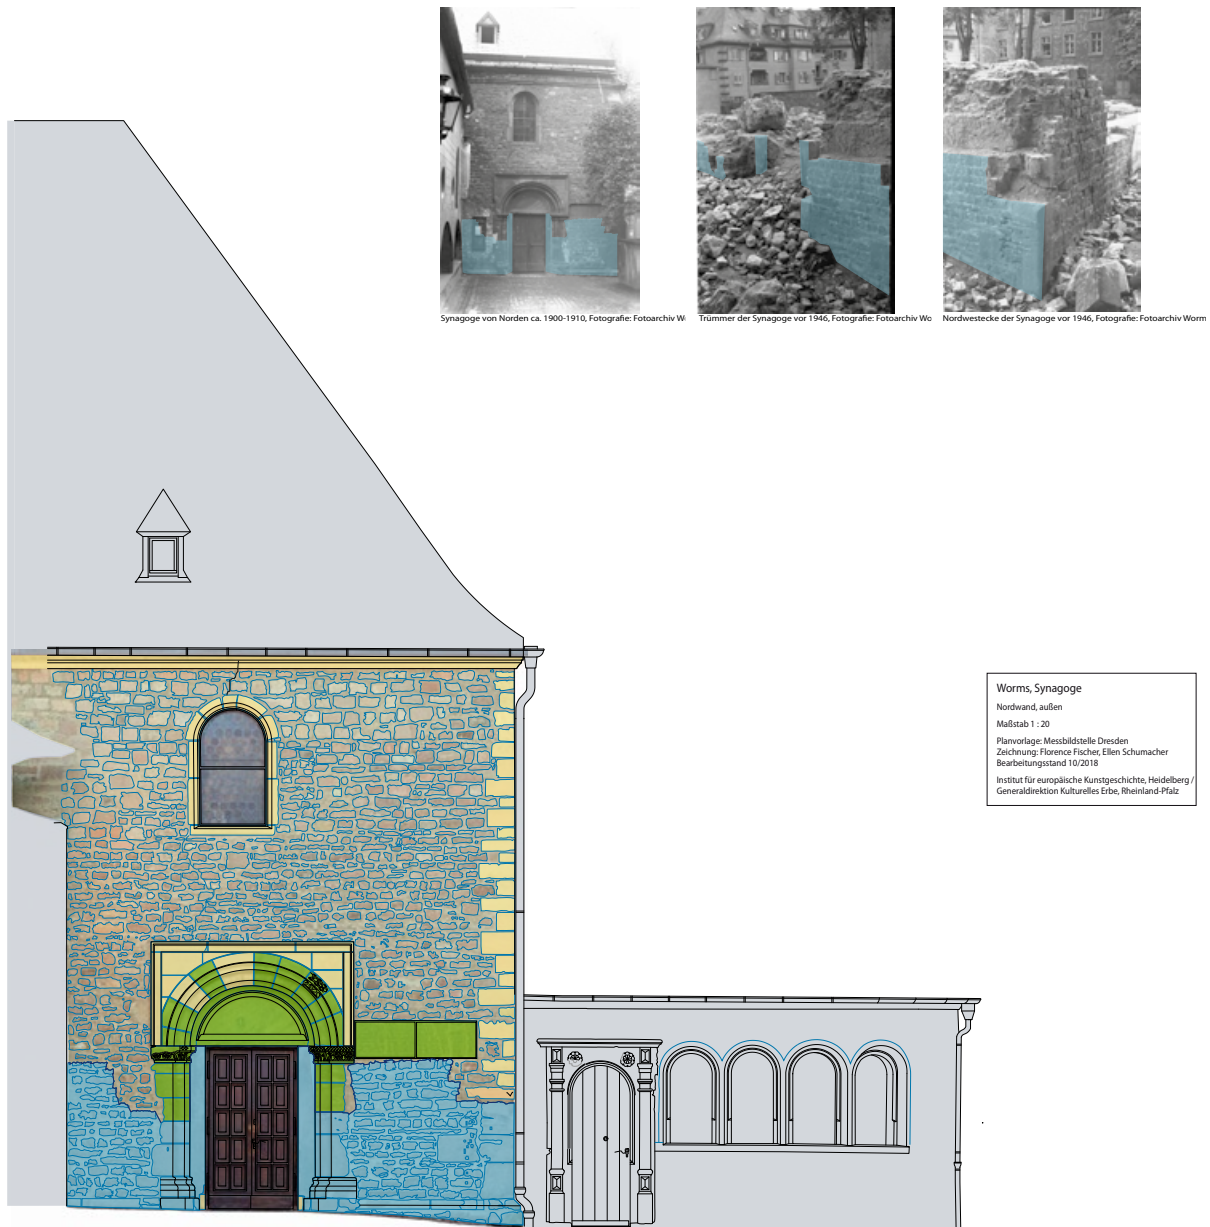
2. Construction phase plan of the north wall of the synagogue
